BIG E

NEW HAMPSHIRE BUILDING

Preliminary Chapter 34 Investigation & Evaluation Report

March 5, 2020

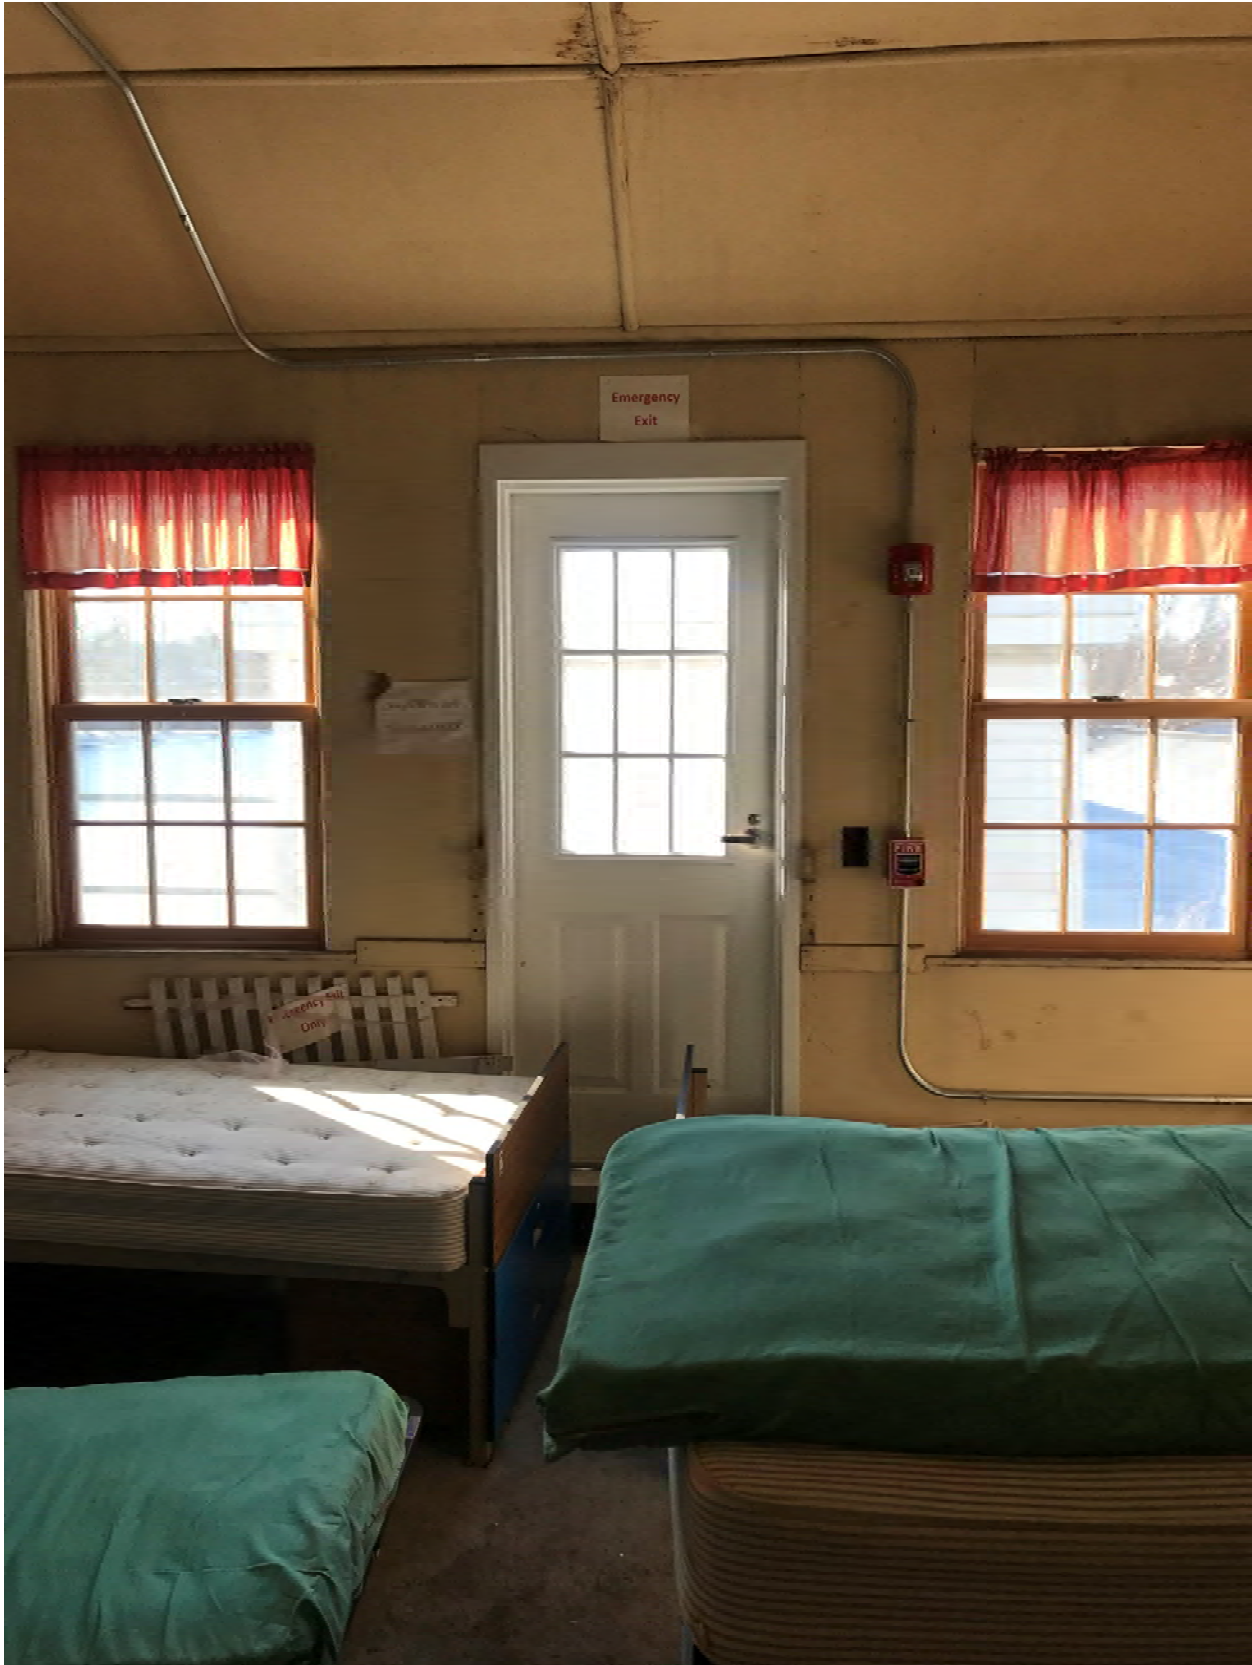
Figure 1 - Obstructed Door and Noncompliant Exit Sign

1. Minimum 36" clear aisles should connect all exit doors and the stairs. This path must be maintained unobstructed at all times.
2. While the steps up to the roof must remain, contrasting marking and warning signs should be provided.
3. All dead bolts should be removed from doors.
4. All knobs should be replaced with lever type handles.
5. Additional emergency egress lighting should be provided to ensure the minimum lumens are provided at the floor (1 foot-candle at the floor) and the emergency lighting is provided for the path across the roof and at the exit discharges.
6. Replace all paper exit signs with internally illuminated exit signs.
7. Remove all storage from the 3rd and 2nd Floors.

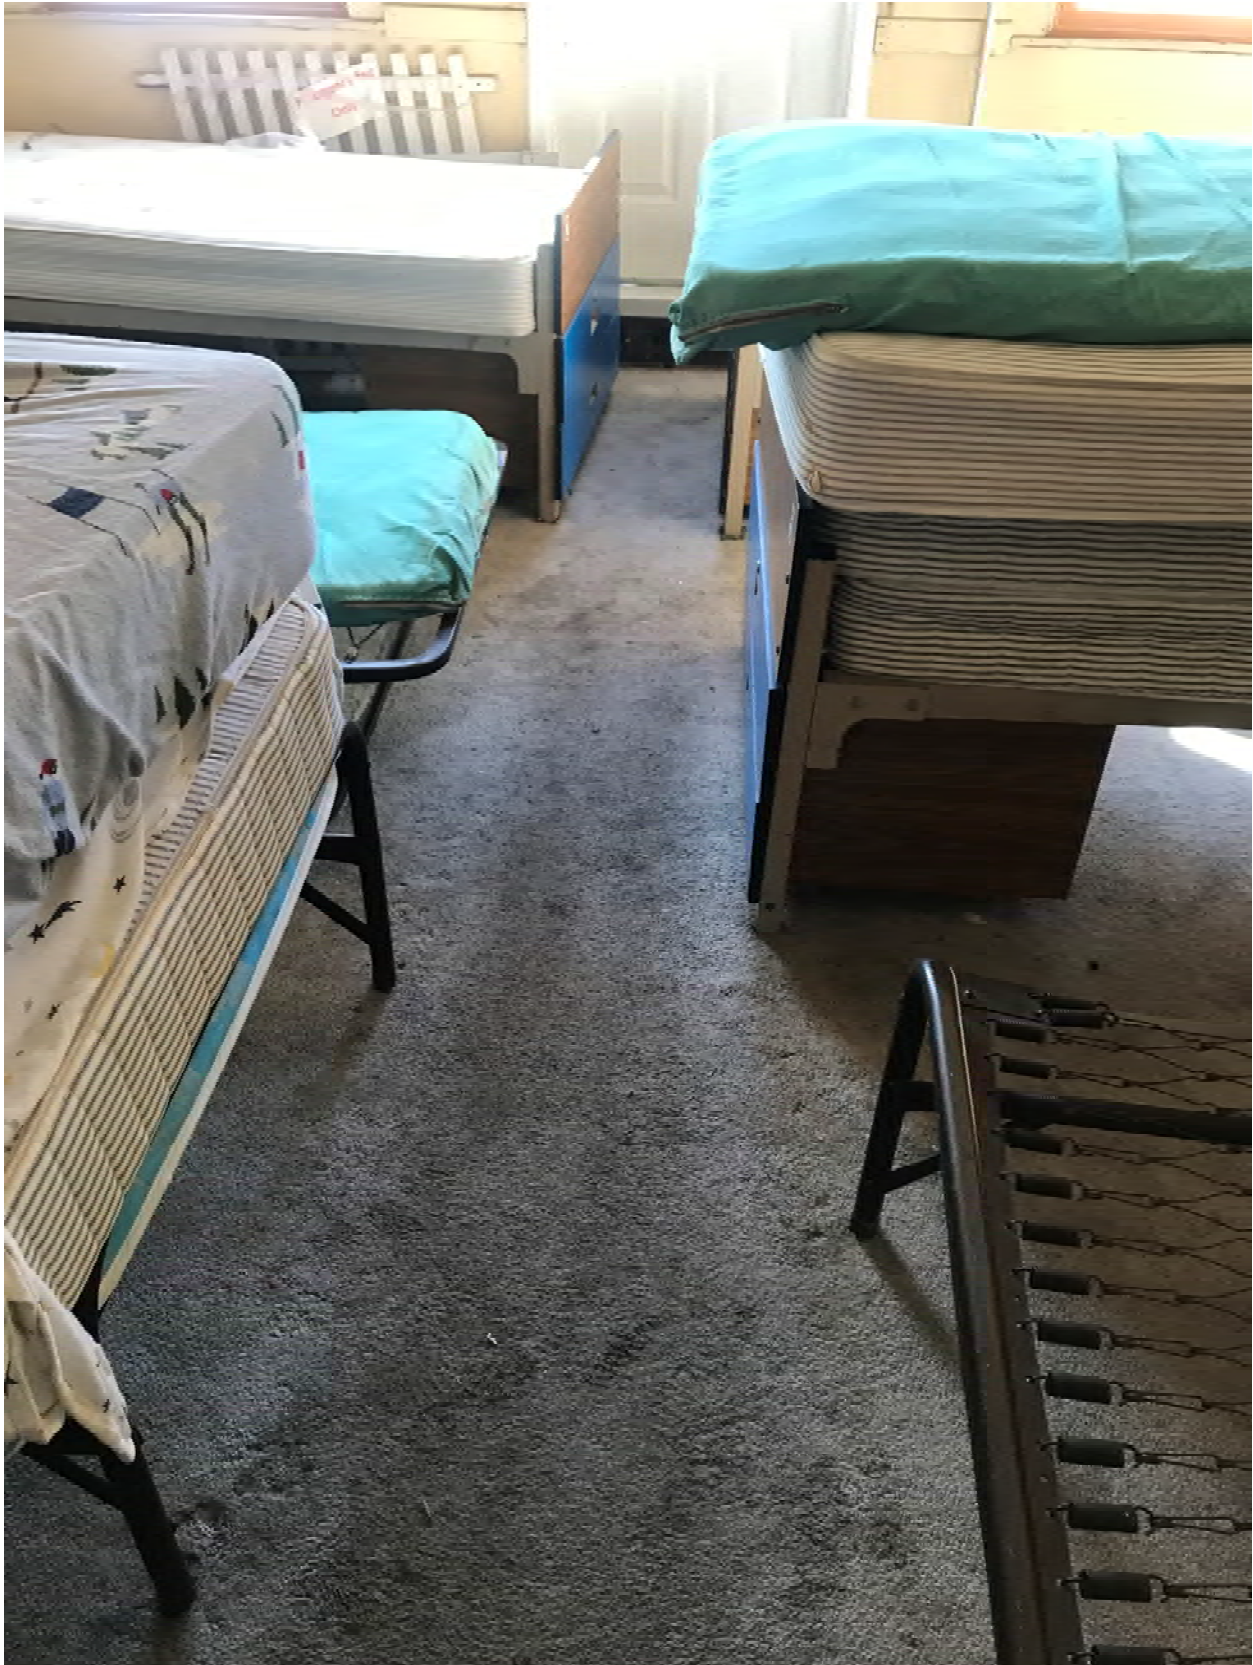
Figure 2 - Same as Figure 1 but Further from Door

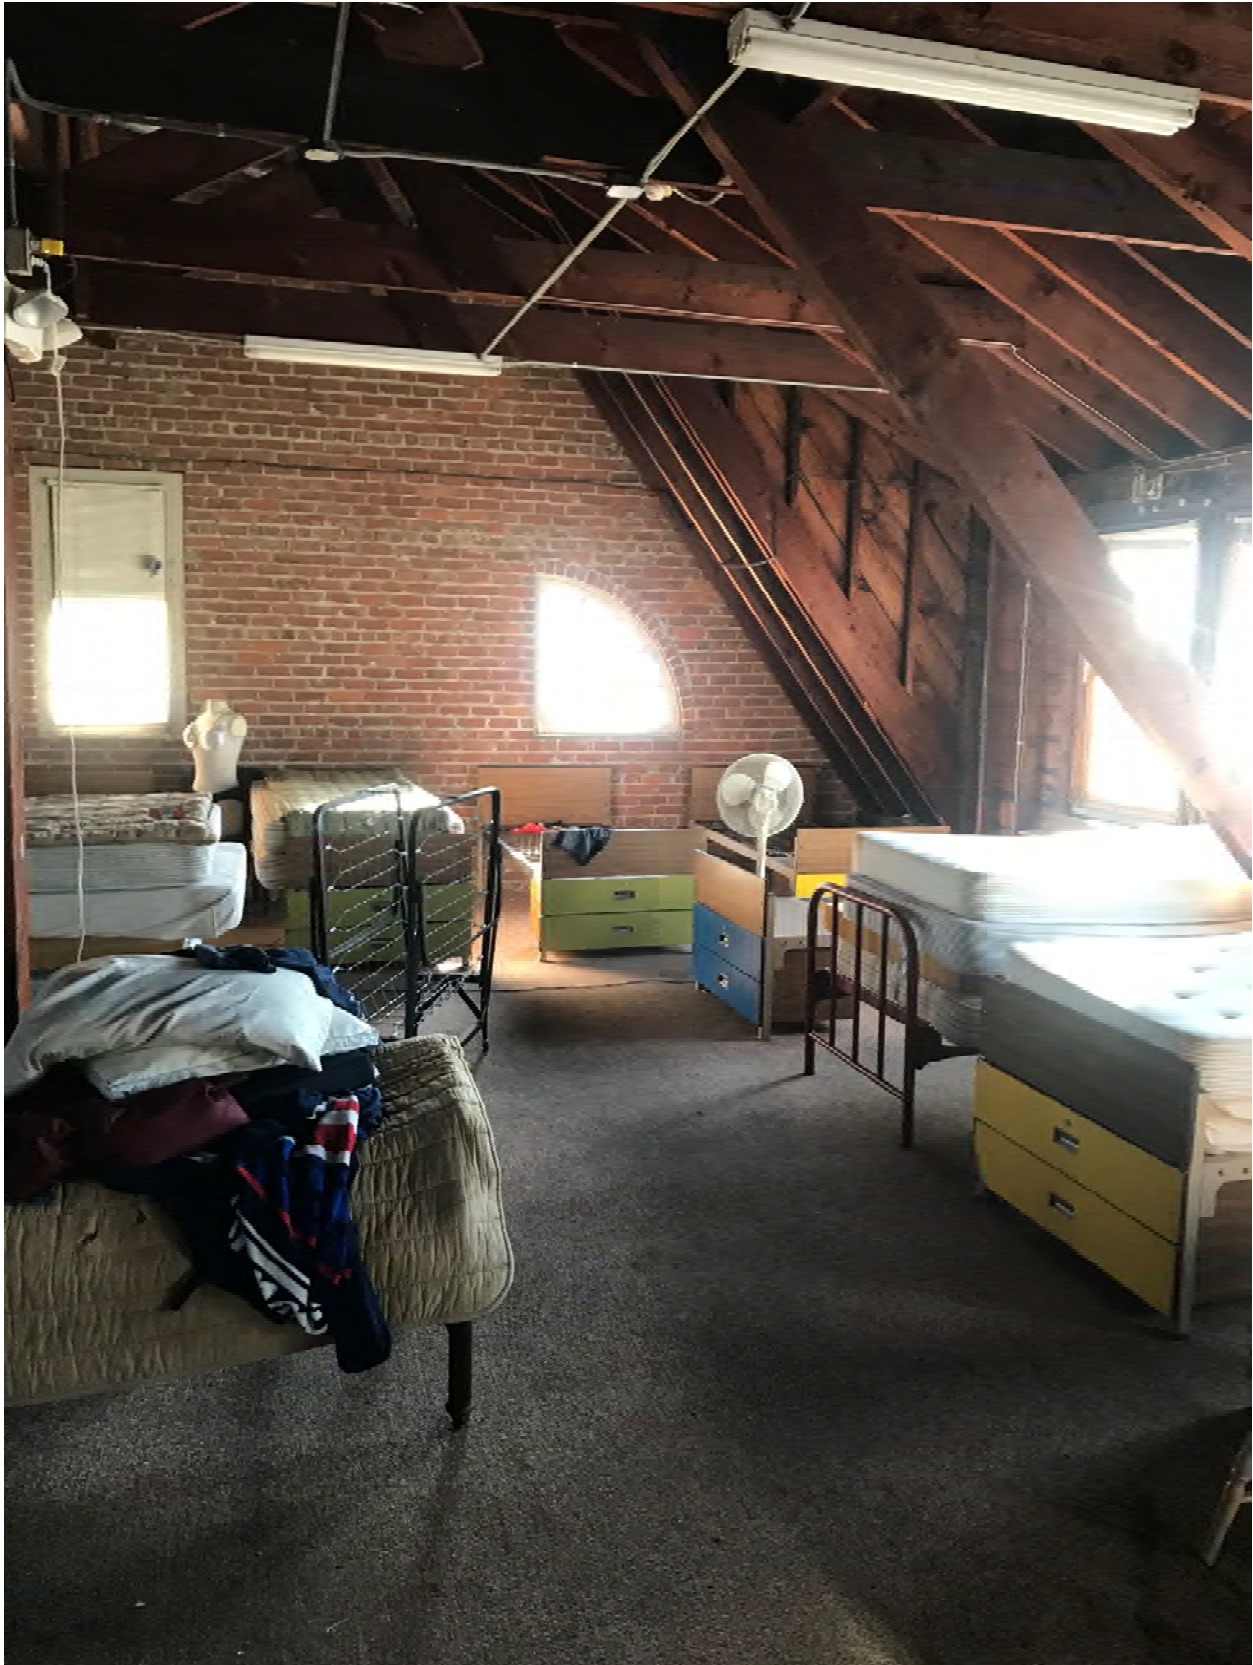
1. The limited aisle accessways provided between beds to reach the exit doors from each sleeping room,
2. Steps up to the roof right at the doors,
3. Door hardware,
4. Emergency egress lighting, and
5. Exit Signage.

Figure 3 - Exit Aisles between Beds is Insufficient

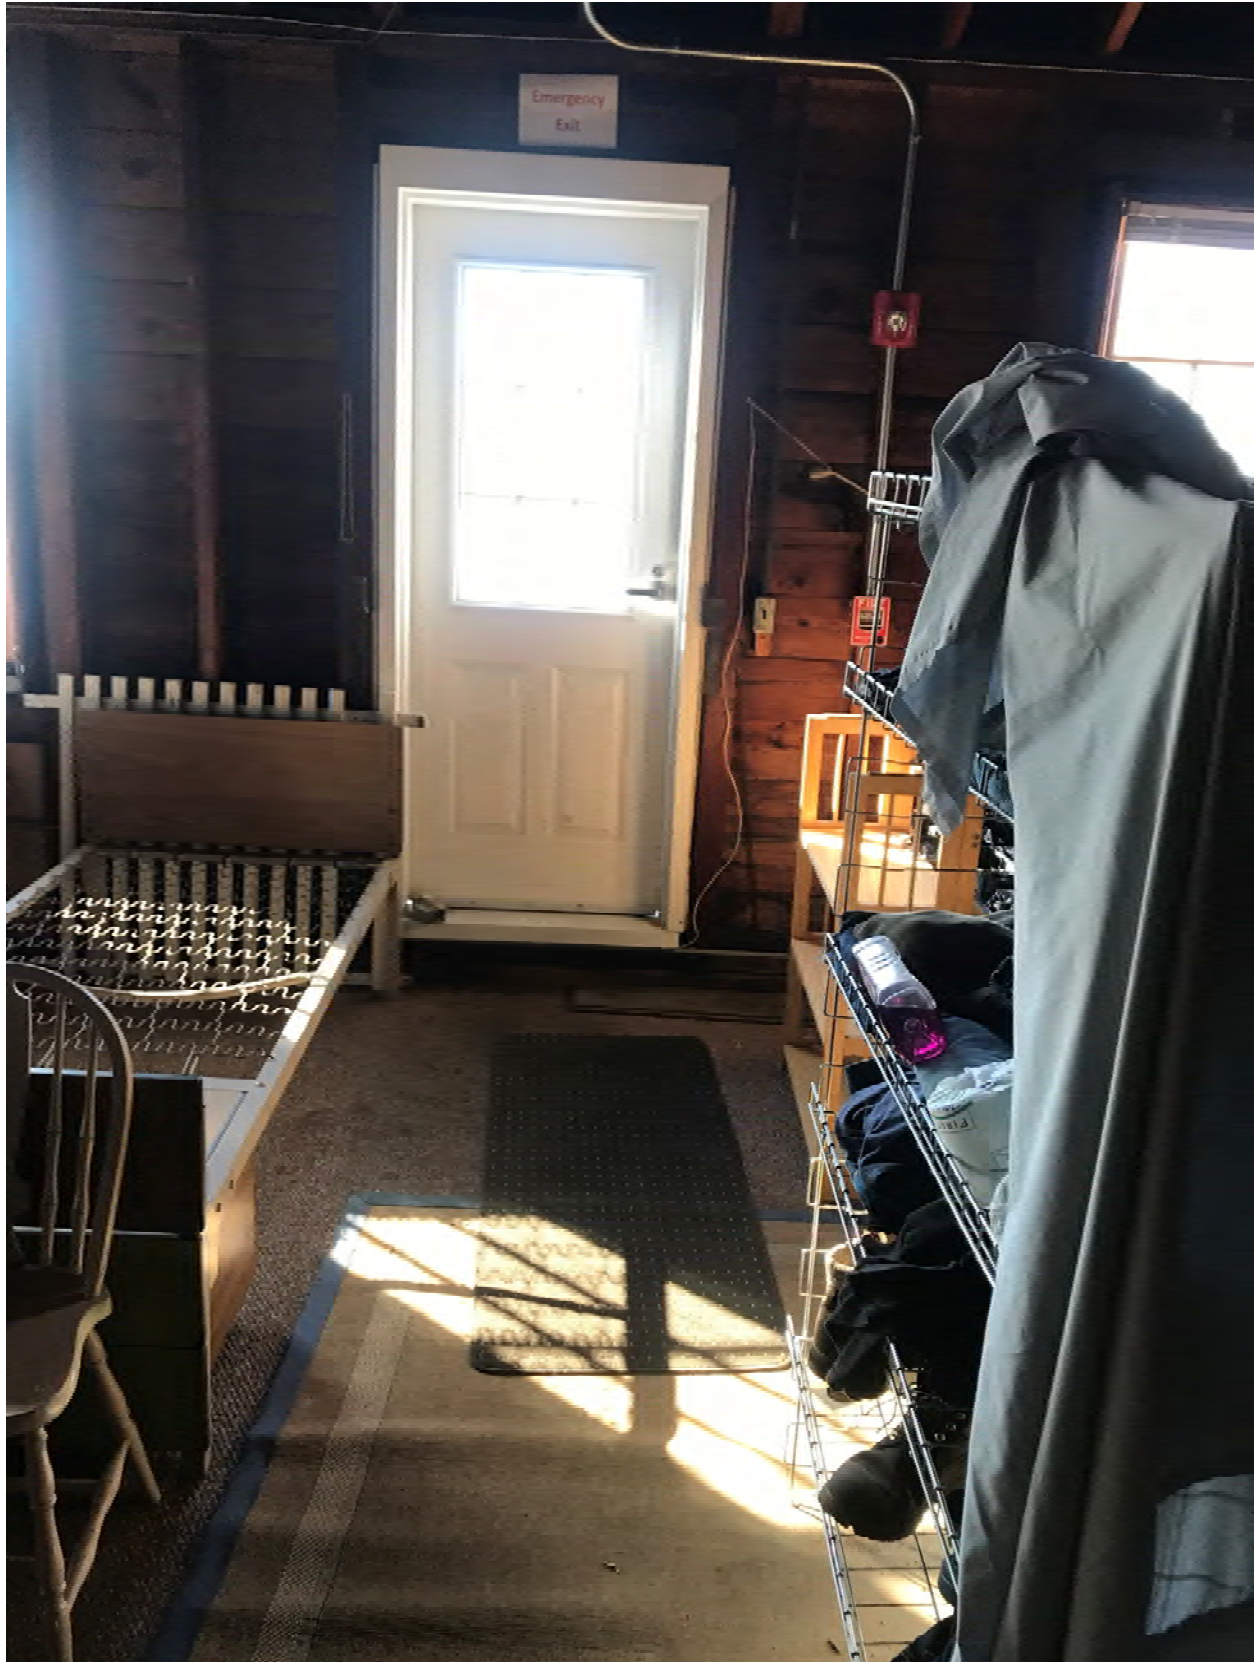
Figure 4 - Another Exit Door Obstructed and Noncompliant Exit Sign

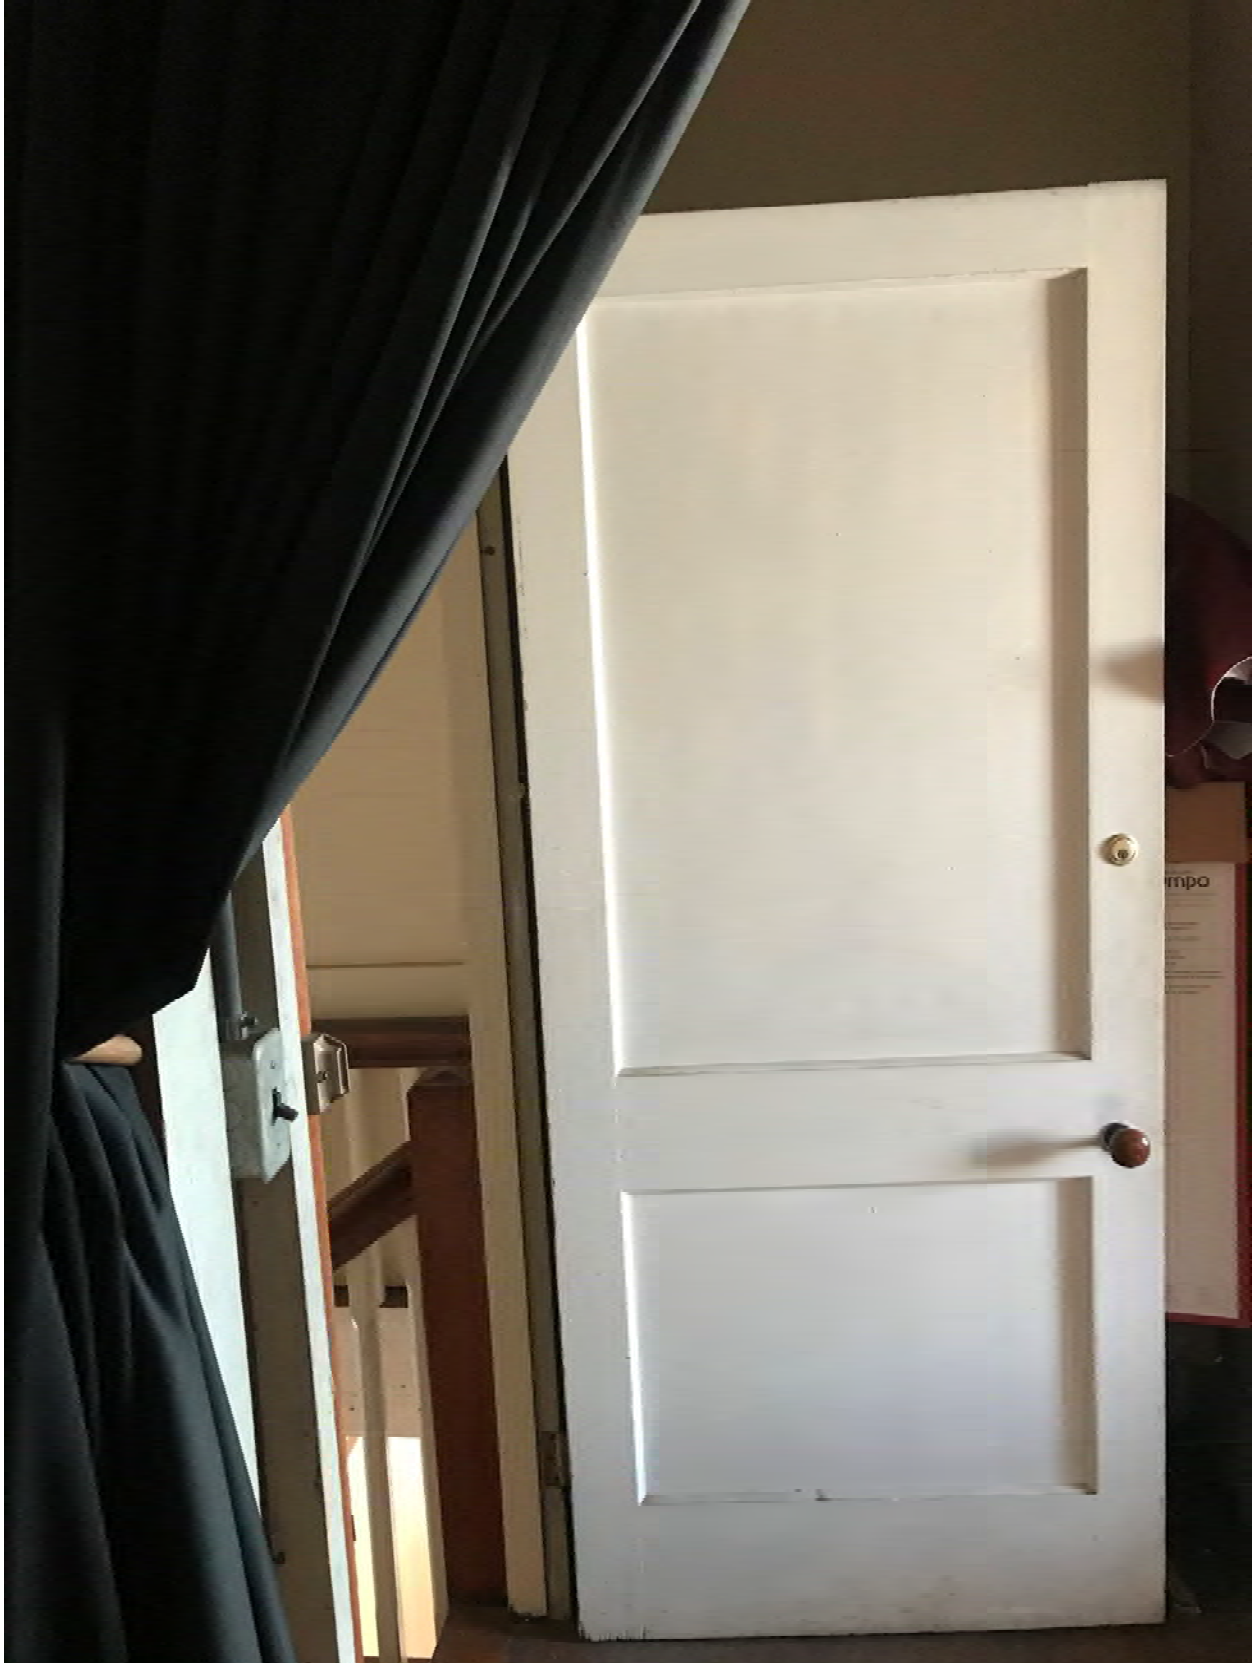
Figure 6 - Noncompliant door hardware and Unpermitted Dead Bolt

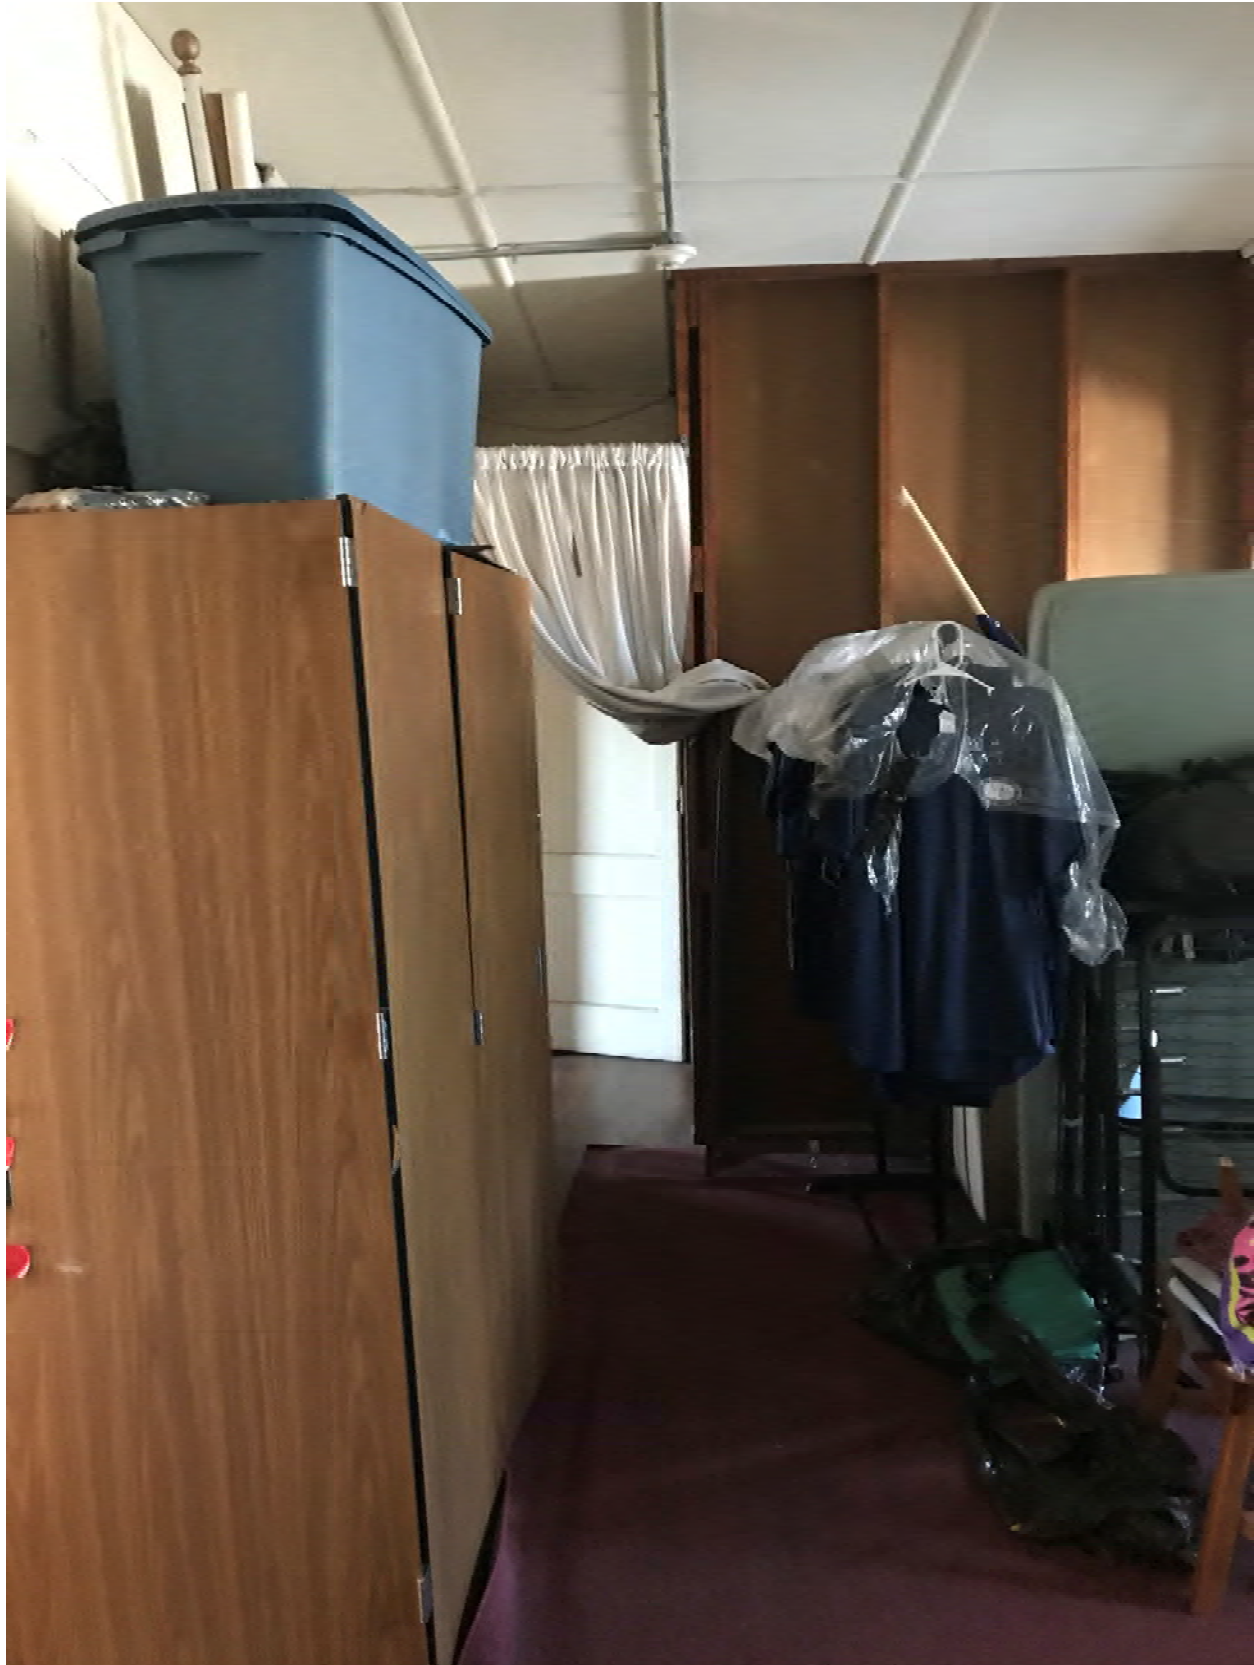
Figure 7 - Move Wardrobe Units and Curtain to Maintain Clear Path to Stairs
