Department of Agriculture, Markets & Food

The New Hampshire Building at the Big E

Capital budget Request

New Hampshire Building at Eastern States Exposition

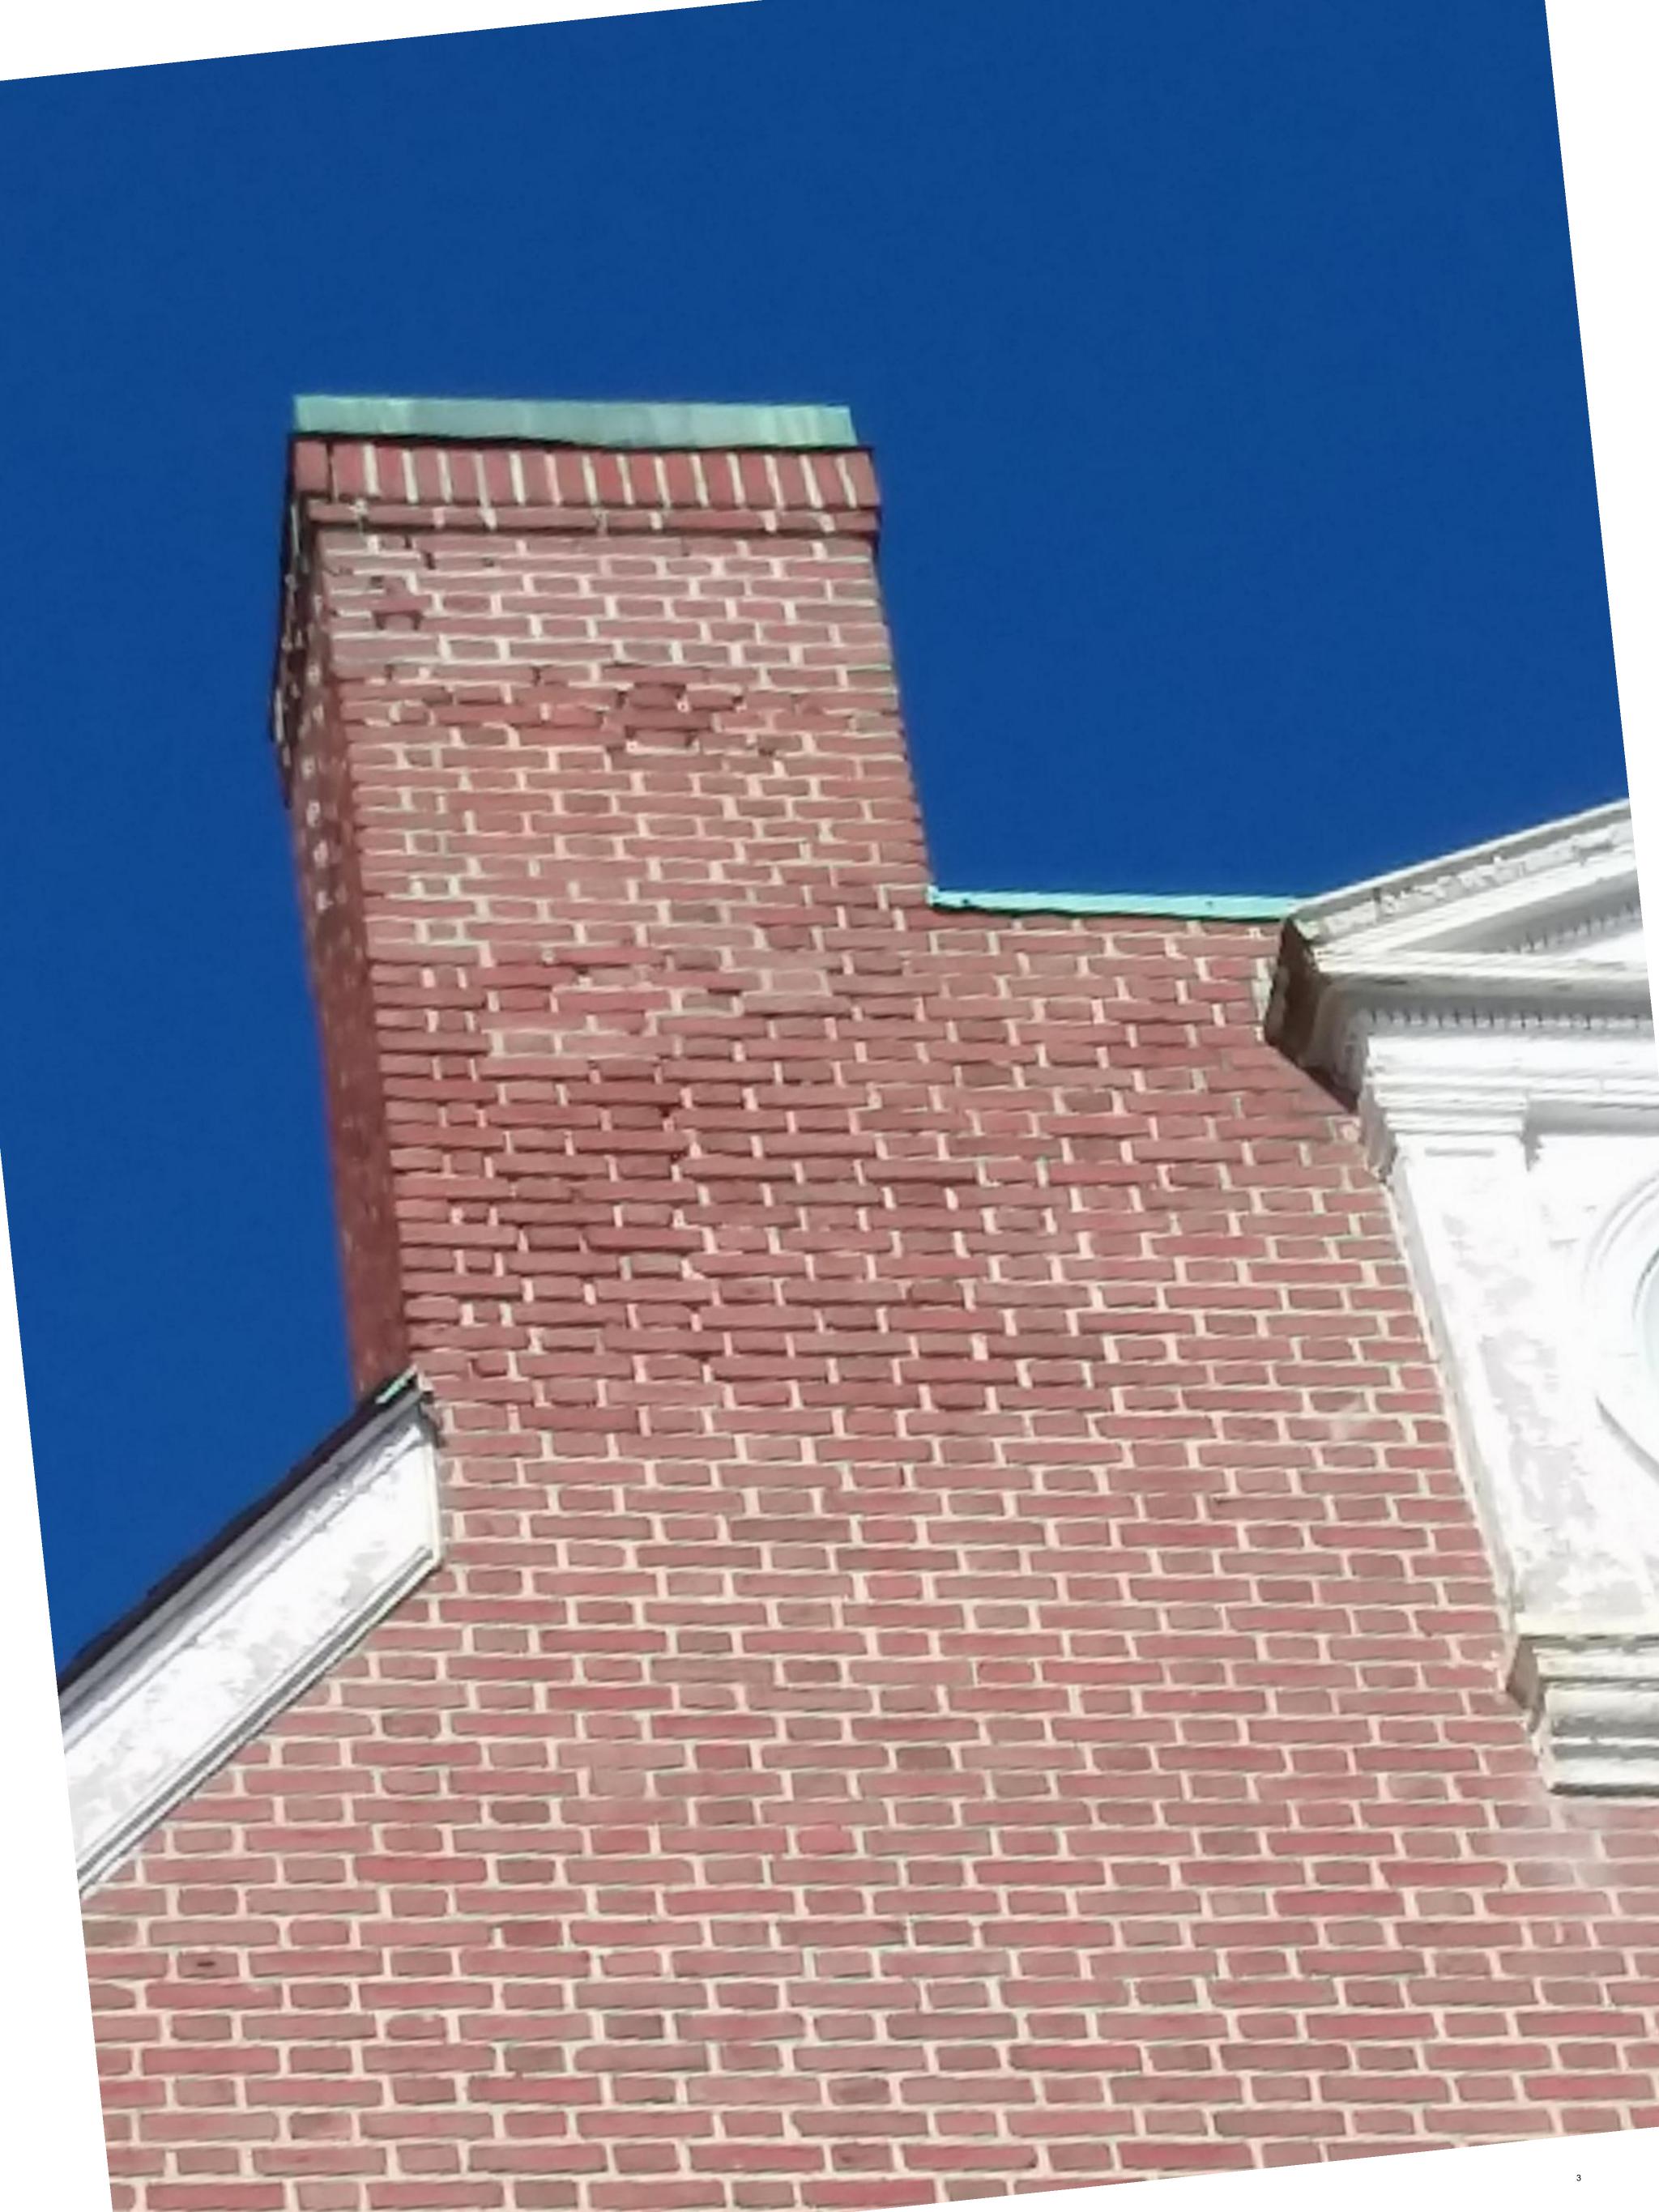
- 1) The brick end walls of the building are in need of repointing. A considerable amount of the mortar has disintegrated. \$27,300.00
- 2) Two faux chimneys have also degraded to the point of public safety concerns and need to be reconstructed. \$60,480.00

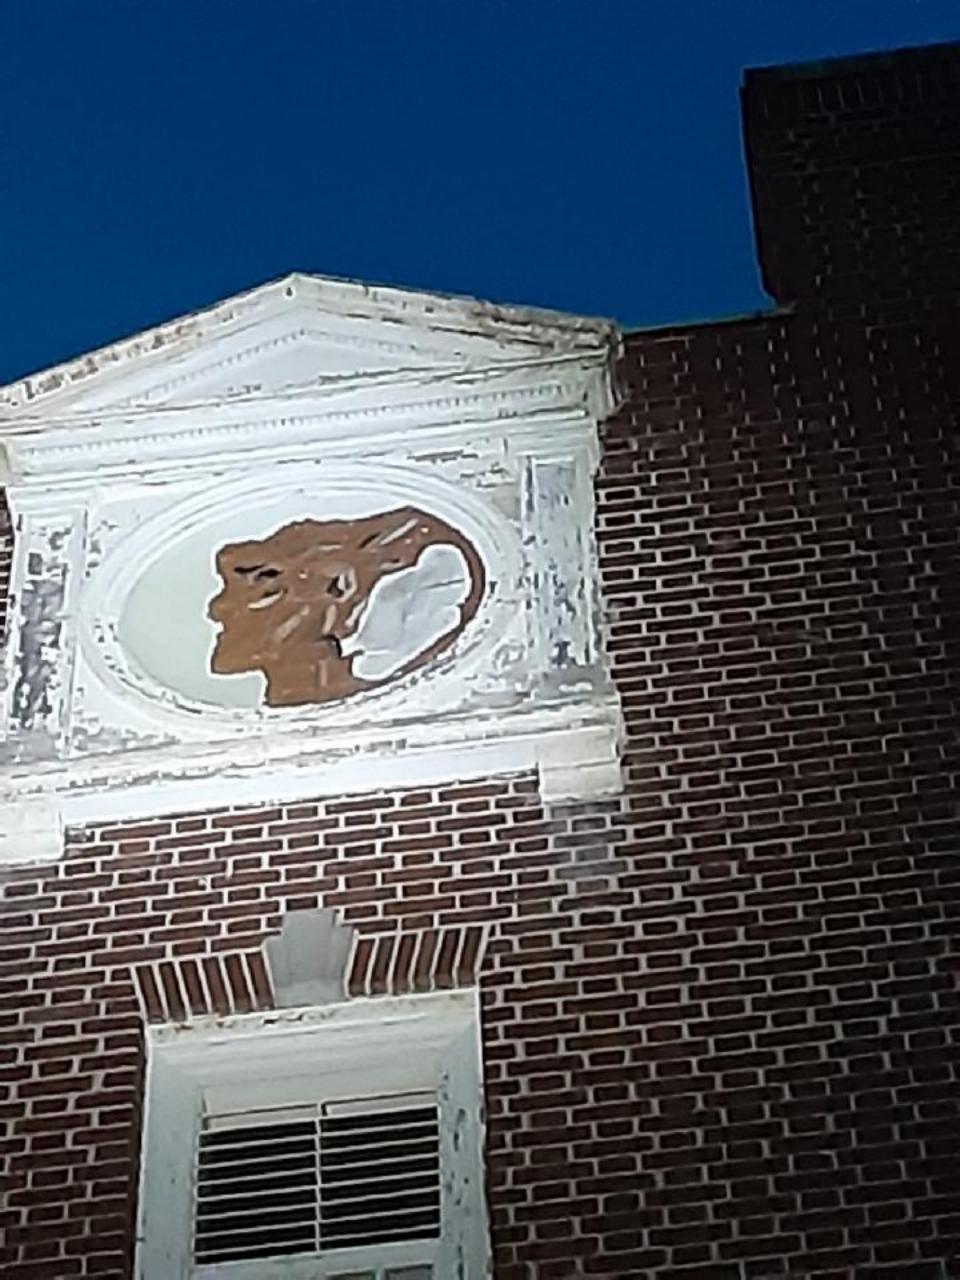
- 4) The wood clapboard siding and trim on the front dormers is showing water damage and rot and needs to be replaced in a manner that preserves the historical appearance of the structure, but ideally is a material that is relatively maintenance free, such as plastic or fiberglass. \$40,000.00
